Gulfstream G280

NUMBER 280-57-099

WINGS (ATA 57) – ADDING A DOUBLER TO
THE FORWARD SPAR AND RIB 0
ATTACHMENT

FEBRUARY 26, 2019

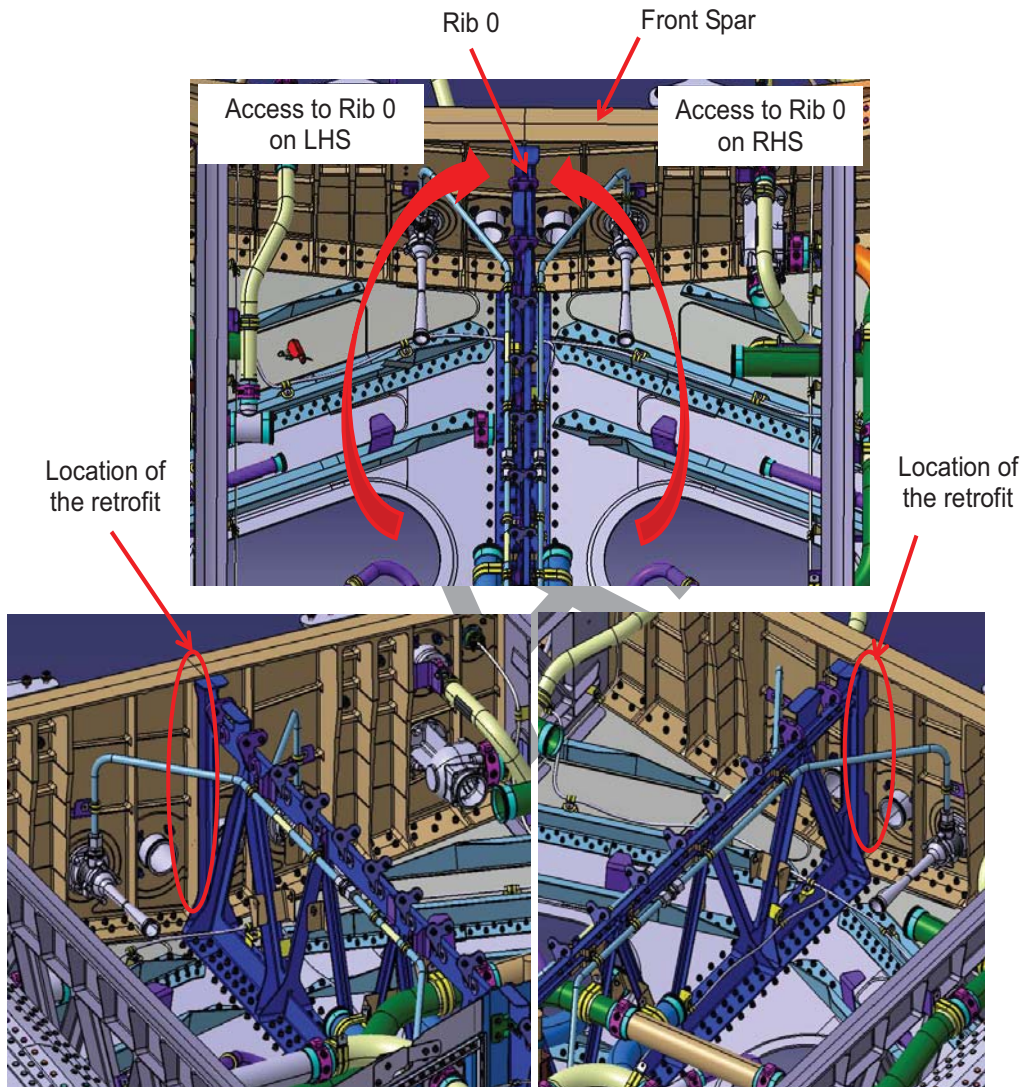
Location for Adding a Doubler Where Rib 0 is Attached to the Front Spar
Figure 6

During full scale fatigue testing, a crack was found in the area of the attachment of wing Rib 0 to the front spar and it was determined that a doubler is needed to be added at that location.

This service bulletin provides instructions to install a doubler at the attachment location of the wing Rib 0 and the front spar.

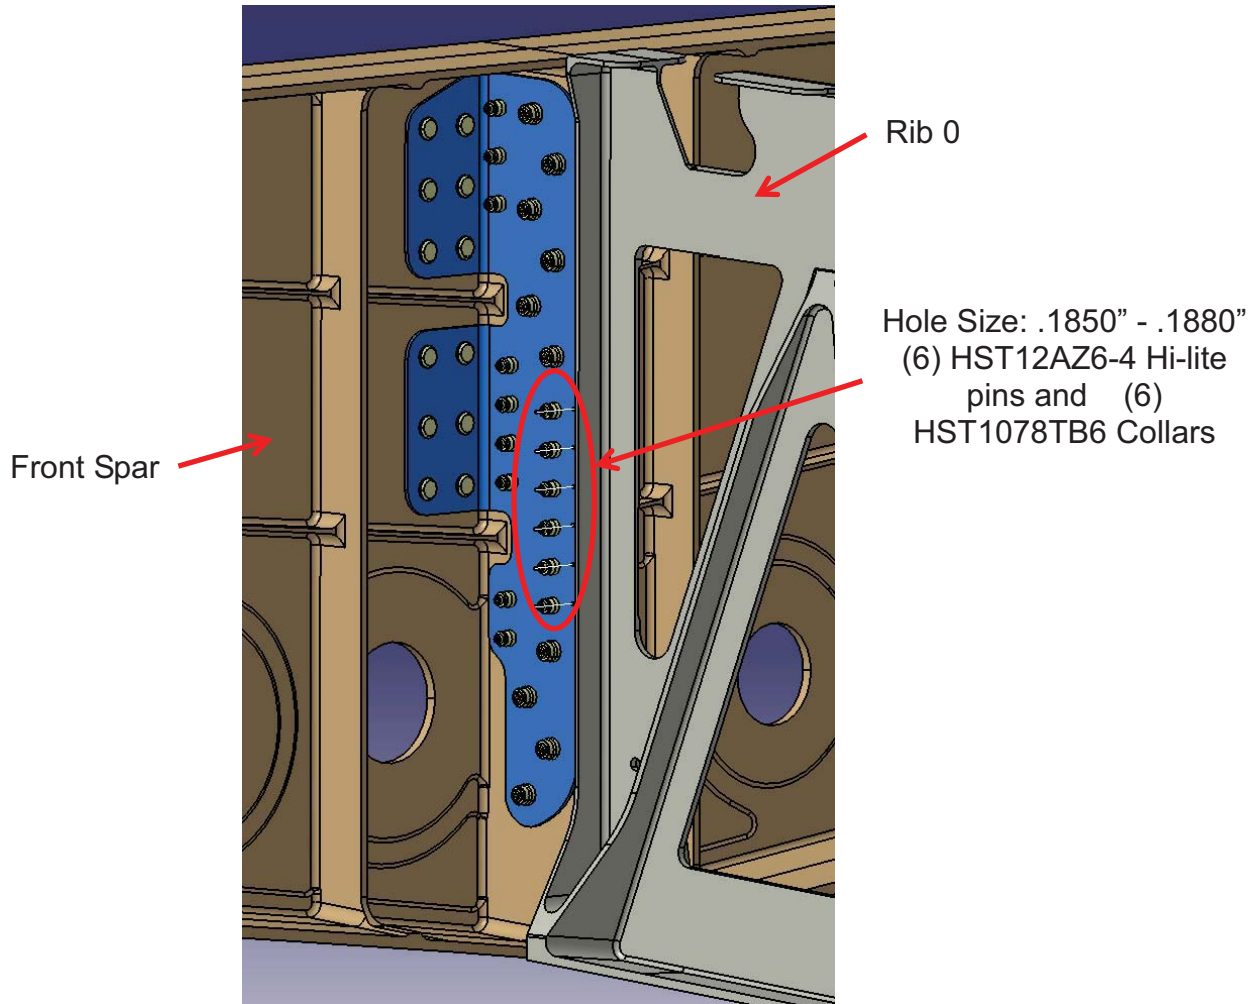
NDT Area to be Performed on Forward Spar Vertical Stiffener and Rib 0
Figure 8

Possible crack

about 70 mm Length

17. On the front spar vertical stiffener and Rib 0, perform the following NDT to inspect for cracks (refer to Figure 8):
 - High Frequency Eddy Current - HFEC (PS810300, PS810310)

- Mid Frequency Eddy Current - MFEC (PS810300, PS810310)
 - Bolt Hole Eddy Current (High Frequency) - BHEC (PS810300, PS810310)
 - Liquid (Dye) Penetrant (PS810100)

18. If any cracks are found, contact Gulfstream Customer Support.

On Spar Stiffener side:

- HFEC & MFEC surface scan around & in-between all fastener holes (total of 12 fastener holes).
- Liquid (Dye) Penetrant NDT only in case cracking indication is found via one of the Eddy Current NDT methods.
- BHEC to the 10 fastener holes of which the fasteners were removed.

On Rib 0 side:

- HFEC surface scan around & in-between all fastener holes (total of 12 fastener holes).
- BHEC to the 10 fastener holes of which the fasteners were removed.
