Gulfstream G280

NUMBER 280-57-099

WINGS (ATA 57) – ADDING A DOUBLER TO
THE FORWARD SPAR AND RIB 0
ATTACHMENT

FEBRUARY 26, 2019

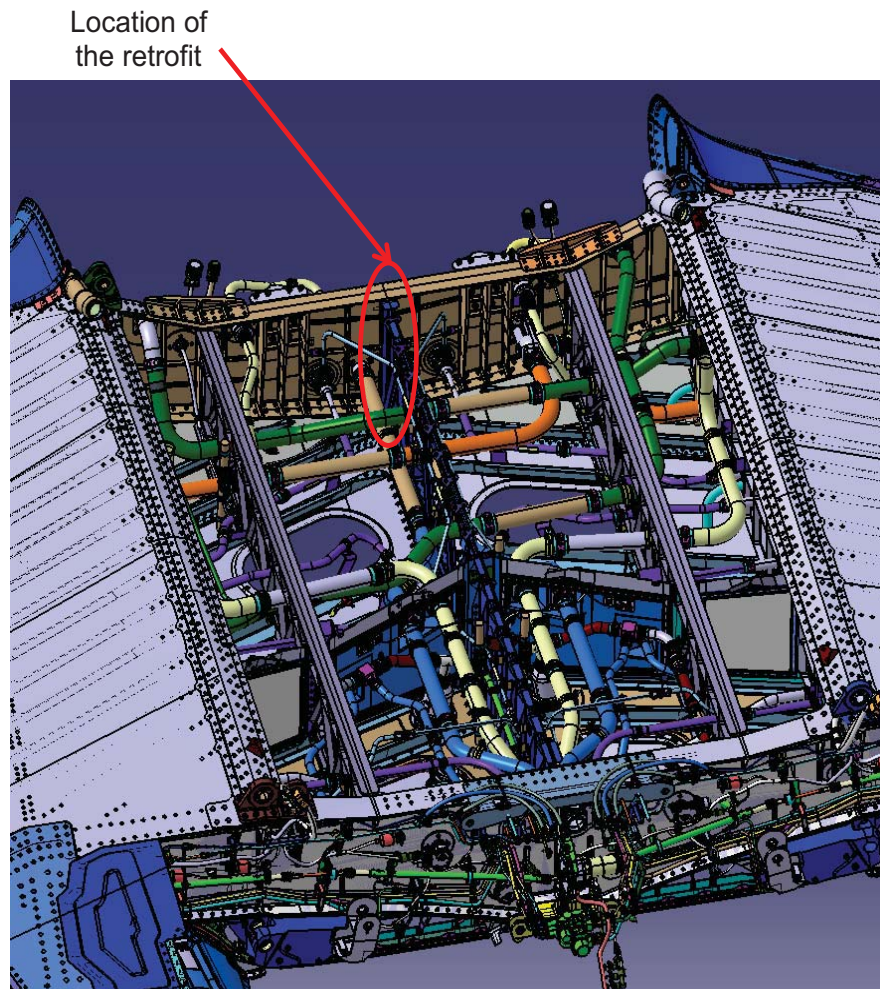
Location of the Retrofit in Center Tank (Wing Skin Removed for Clarity)
Figure 4

During full scale fatigue testing, a crack was found in the area of the attachment of wing Rib 0 to the front spar and it was determined that a doubler is needed to be added at that location.

This service bulletin provides instructions to install a doubler at the attachment location of the wing Rib 0 and the front spar.
